Full Mouth Rehabilitation of a Patient with Severely Worn Molars: A Case Report

KEYWORDS: worn dentition, full mouth rehabilitation, full mouth reconstruction, PFM restoration

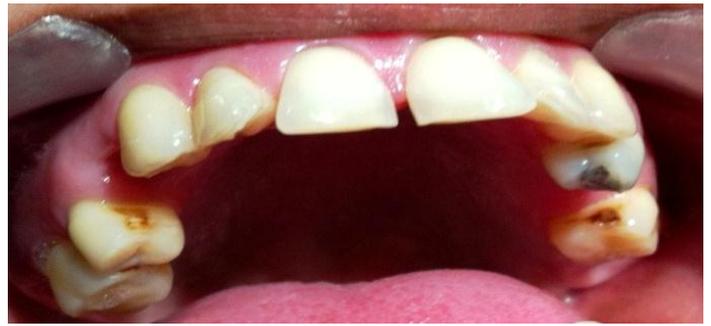
fig 1b. Maxillary arch with attrition in molars, fractured and wearing pattern on lingual aspect of anteriors

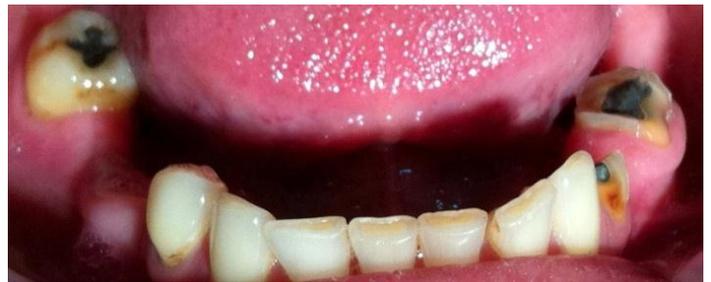
fig 1c. The mandibular arch with severely worn molar and premolar teeth and also on incisal aspect of incisors.

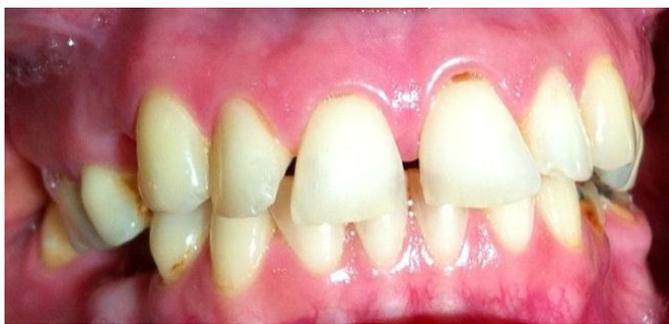
The loss of VDO was assessed by evaluation phonetics and interocclusal space^{12,15,17}. Patient was asked to pronounce the letter 'S' it sounded like 'SS' whenever there is increased distance between mandibular incisors and lingual surface of maxillary incisors the letter 'S' will be heard like hissing sound. Ideally it should be 1mm.

The interocclusal rest space was measured between tip of the nose to chin tip it was 6-7mm ideally should be 2-4mm. Wrinkles and accentuated angle of the mouth suggested severe loss of VDO.

fig 1a. Front view showing loss of vertical dimension, the supra eruption of maxillary molar.

occlusal height warranted for root canal treatment. Hence we planned for metal ceramic bridge and crowns from canine to molars on all the side with increased vertical dimension. Since patient molar teeth were attrited to large extent it was decided to do preparation of teeth and giving temporary bridge in methyl methacrylate resin with increased vertical dimension of about 2-3mm in the premolar region, patient was asked to continue with provisional crown for 4months and patient was observed periodically for any TMJ problems or muscle soreness and comfort.

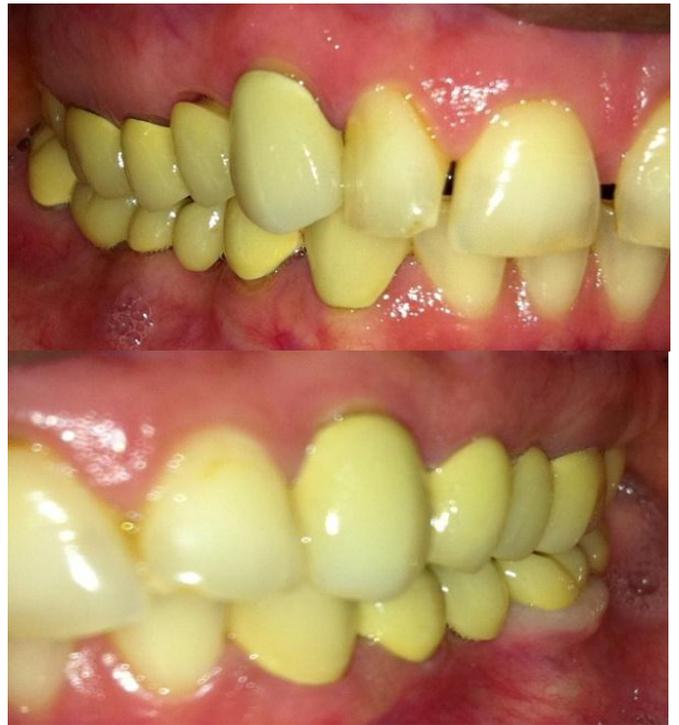
Fig 3, The final prosthesis in place.

Patient was recalled once in 10 days and observed for any muscle tenderness, discomfort in TMJ and any change in the function of mastication, speech, swallowing. Any adjustment needed were done for the betterment of mastication, facial aesthetics were carried out. The provisional bridge was maintained for 4 months and patient's tolerance for new mandibular position and increase in VDO was confirmed. Final preparation was performed and definitive impressions were made with poly vinyl siloxane impression material. Bite registration was taken using provisional bridge. Porcelain fused to metal restoration was made with try in of metal frame work and final restoration was cemented using glass ionomer cement. Since the acute anterior guidance was maintained even in final restoration the

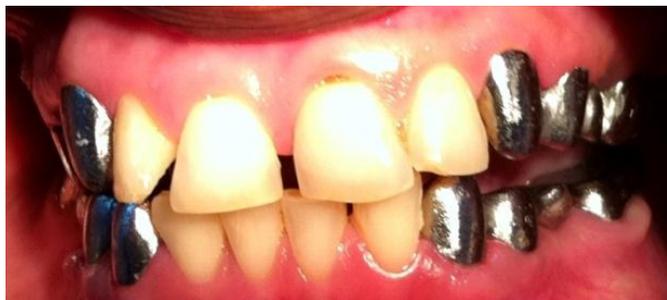
fig 2. The metal try in
